Oysterponds Historical Society Collections Care Plan

Oysterponds Historical Society
1555 Village Lane
Orient, NY 11957

Jan Hird Pokorny Associates, Inc.
39 West 37th Street, Floor 12A
New York, NY 10018
212-759-6462

May 23, 2019

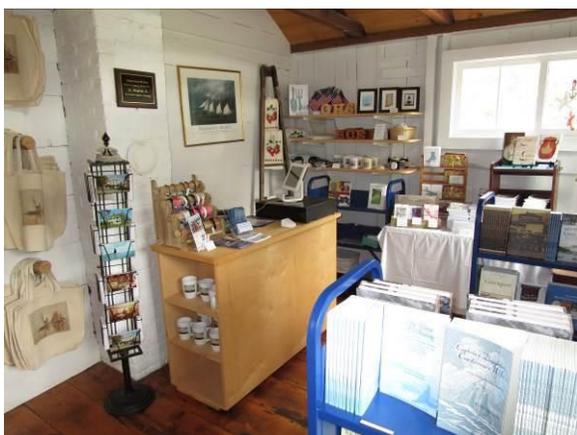
Photo No. 3: The gift shop located at the rear addition is out of the circulation path of the house, limiting foot traffic.

- Further organization to second-floor collections storage rooms to accommodate more efficient storage of artifacts.
- Consider relocation or discontinuation of the gift shop (142 square feet) (moving sales online) in order to take advantage of this room's climate stability and ADA accessibility to display more of the collection.
- Rely on mobile experience on an iPad (already in place) rather than dedicated AV space so that the room currently serving this purpose (62 square feet) can be used to display more of the collection.
- Introduce public programming on the patio during summer months, potentially with a tent or sailcloth to provide protection from sun and rain.

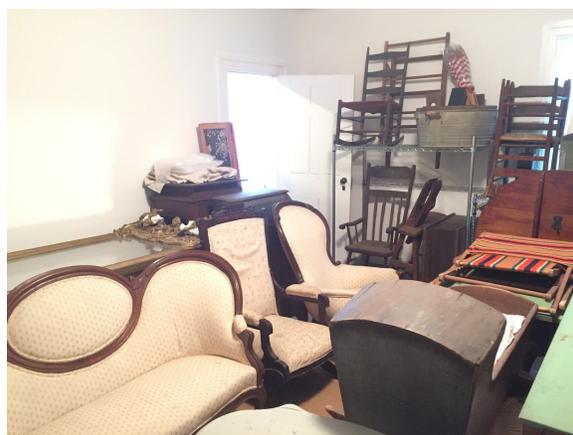
The second floor exhibition galleries are thoughtfully presented and work well. The remainder of the second floor, representing approximately 50% of the floor area, is used for collections storage. While the staff have worked to organize these areas, making improvements in how items are stored, additional reconfiguration could make these areas even more efficient.

Photo No. 4: Some of the storage areas on the second floor could be reorganized for greater efficiency.

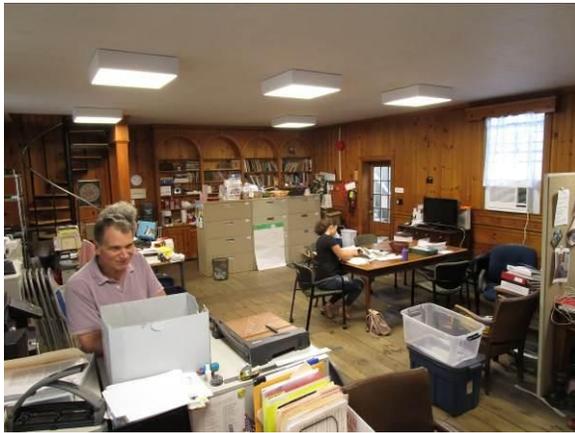
The communal office in the basement does not have a modern office environment and lacks space for private meetings or phone calls. The open floor plan of the first floor makes it suitable for its current use for exhibitions. The first floor space also lends itself to multi-use programming, but it cannot adequately serve both these purposes at the same time, as sometimes happens now when children's programs take place there during an exhibition and both feel crowded. Access to the attic is unsafe and therefore this space should no longer be used for storage of any kind. If access were improved it could be used for storage of non-collections items, but it is unlikely to be worth the cost and effort to do so.

Photo No. 7: The communal office space affords no privacy. The basement space is quite damp.

- Relocate staff offices to Vail House.
- Use the basement for storage of exhibition cases and furniture and/or a buildings and grounds workshop.
- Introduce family-friendly public programming on the porch and the green space to the north during the summer season.

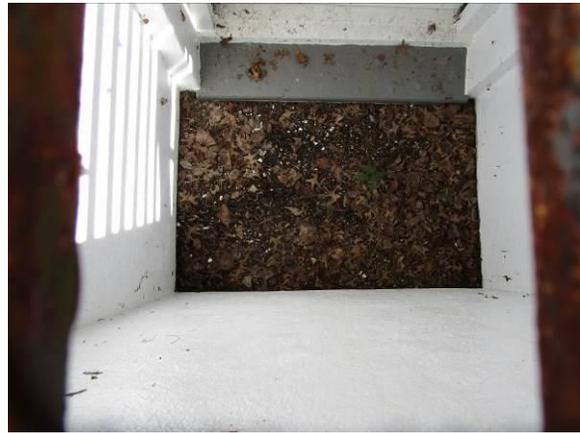
Photo No. 8: The window wells are a weak spot in water drainage management, despite recent improvements.

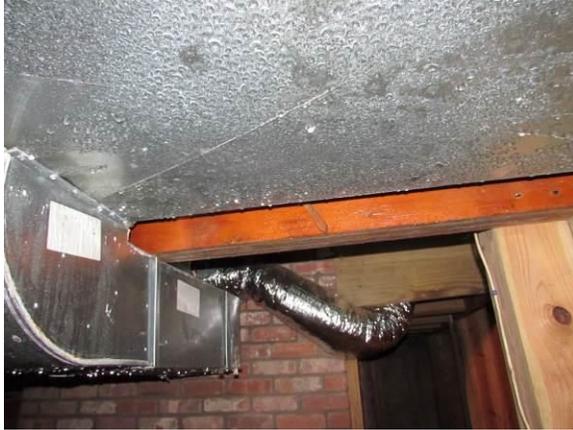
Excessive moisture and tidal flooding render the basement of the house unusable. The current program of period rooms on the first and second floors has become static and needs a new creative approach to draw more visitors to the house. One room on the second floor has been functioning as a storage space; while this room seems underutilized, holes in the floor make it inappropriate as public space unless the floor is fixed (we understand that work is currently underway to repair the floor). The heat load within the attic renders it unsuitable for storage of historic material. The environment in the Webb garage is inappropriate for collections storage, although it can be used for storage of non-collections items or maintenance equipment. The ice

Photo No. 11: The basement is very wet from condensation, tidal flooding, and general humidity.

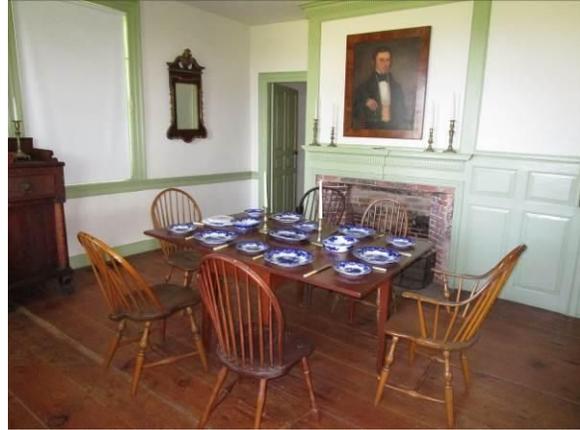
Photo No. 12: The period-interpreted rooms are well executed but have gotten stale.

- Refresh the period rooms with a more dynamic approach to bring new energy and visitors to the house.
- Finish repairing the floor in the collections storage room on the second floor, and consider relocating the items stored there so it can become an additional exhibition space.

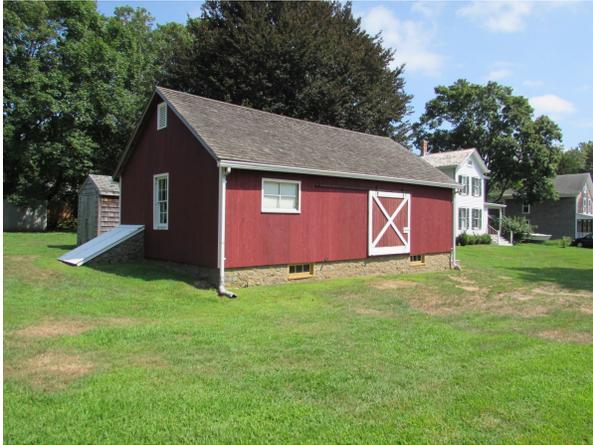
Photo No. 13: The exterior of the red barn was recently restored and is in good overall condition.

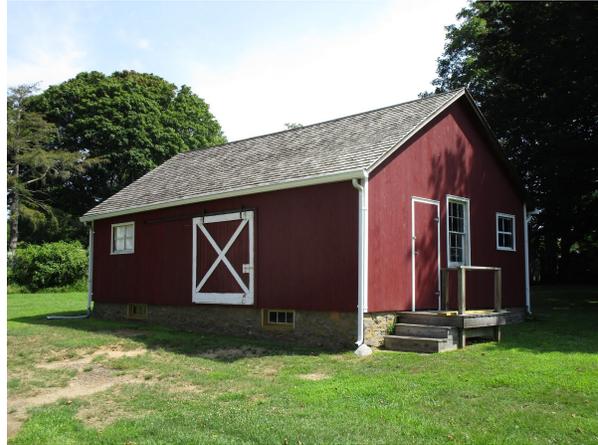
Photo No. 14: The main floor could be made ADA compliant with the addition of a ramp towards the rear of the barn.

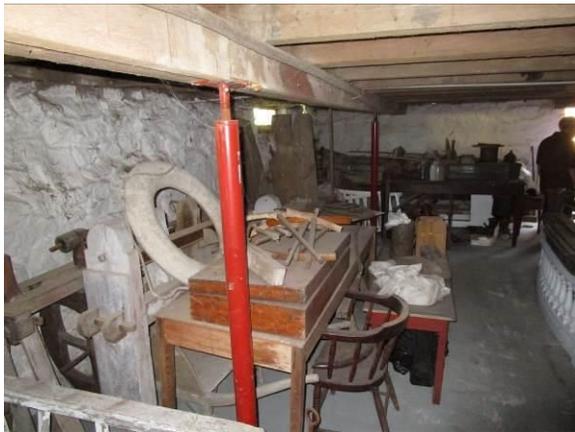
In the basement, collections items are stored with non-collections items; they should be separated to avoid confusion.

Photo No. 15: The basement storage area is damp.

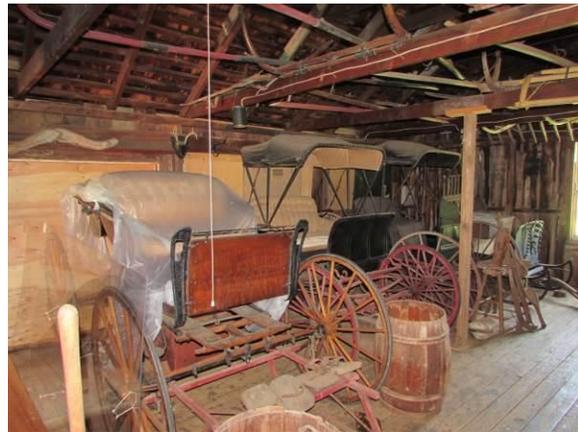
The tightness of the current layout on the first floor, which is packed with horsedrawn vehicles, prevents these from being fully visible to the public, a lost opportunity from an exhibition standpoint. (The building is not currently open to the public.) OHS would be better served by deaccessioning two to three of the vehicles with the least historical significance to Oysterponds to create enough circulation space for the first floor to be open to visitors (the Collections Committee is currently exploring this possibility). Several sections of wall on the first floor bear the signatures of former Oysterponders. These signatures add significantly to the sense of place in the Red Barn and should be preserved.

Photo No. 16: The collection pieces on the first floor are cramped, limiting access for proper display.

- Deaccession two or three vehicles with limited historical significance to Oysterponds to create space for visitor flow so the first floor can be open to the public during the summer season.

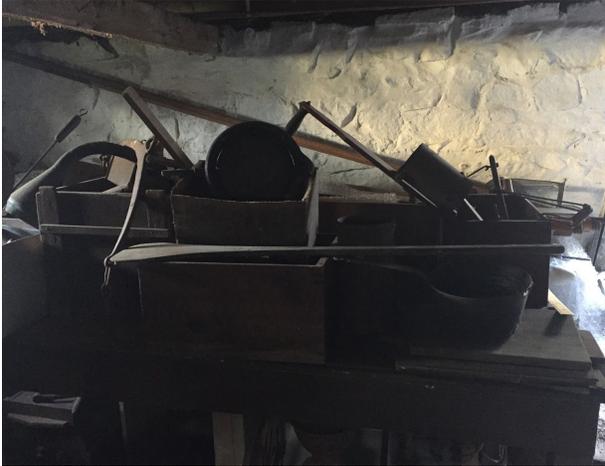
Photo No. 17: Objects in the basement would benefit from shelving for better organization.

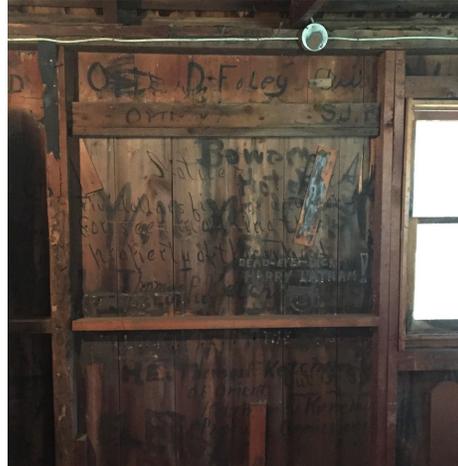
Photo No. 18: The historic signatures on the wall of Red Barn's main floor should be protected.

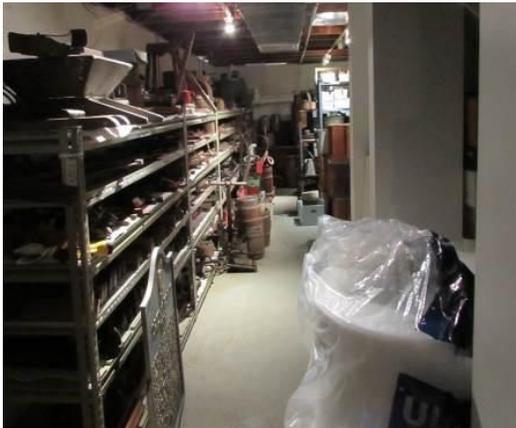
Photo No. 21: The basement storage area is poorly lit, and has some moisture issues.

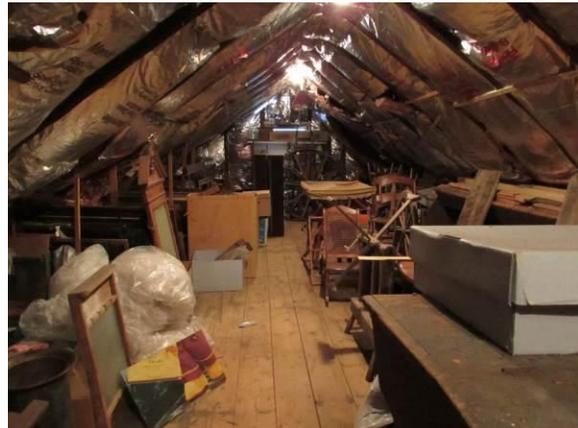
Photo No. 22: Although artifacts are stored in the attic, the conditions are not suitable.

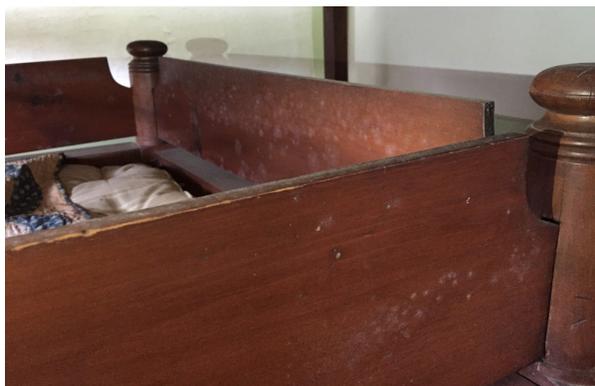
Photo No. 25: An example of mold/mildew on artifacts in Webb House.

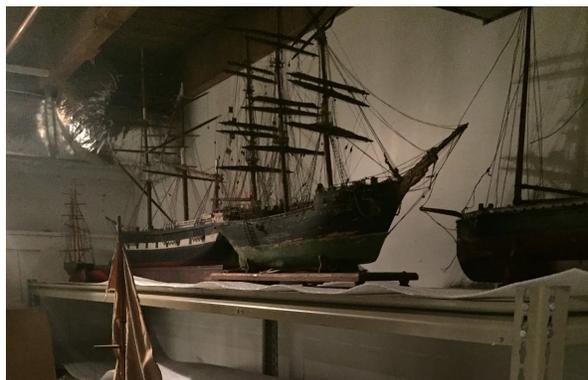
Dust. Over time, dust and other particulate pollutants can damage the surface of collection objects. The longer dust stays on objects, the more difficult it is to remove. Currently OHS relies on hand-dusting both objects on long-term display and much of collections storage. But because the collection is quite large, so much dusting on a regular basis becomes unrealistic and is a drain on staff time. OHS needs upgrades to collections storage—more archival boxes, closed storage cases, and dust covers—to protect objects from dust landing on them in the first place.

Photo No. 26: The maritime conservation fund will pay for cases to protect these ship models from dust.

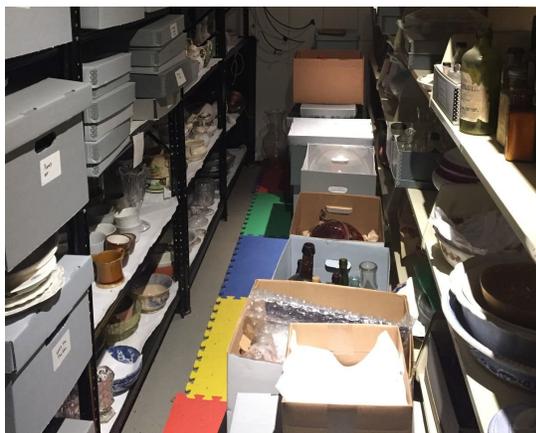
Photo No. 27: Artifacts overflowing in aisles of collections storage in Hallock basement.

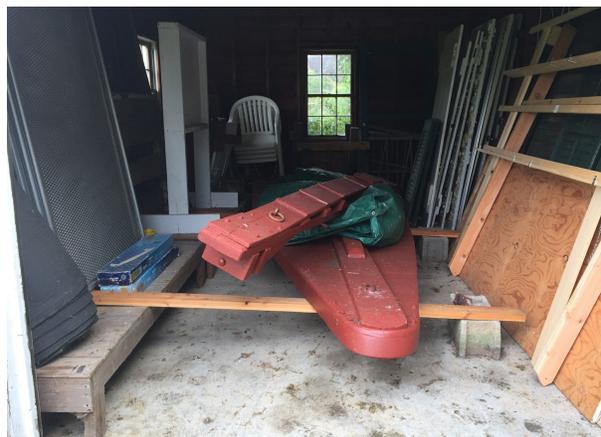
Photo No. 28: Parts of the ice boat currently stored in the Webb House garage.

boat should be removed from the garage and relocated to a designated collections storage area (the Red Barn is the most appropriate place for it).
